NRL/PU/6110- -99-388

## Advanced Nontoxic Fouling Release Coatings

July 27, 1999

Environmental Security  
Technology Certification  
Program

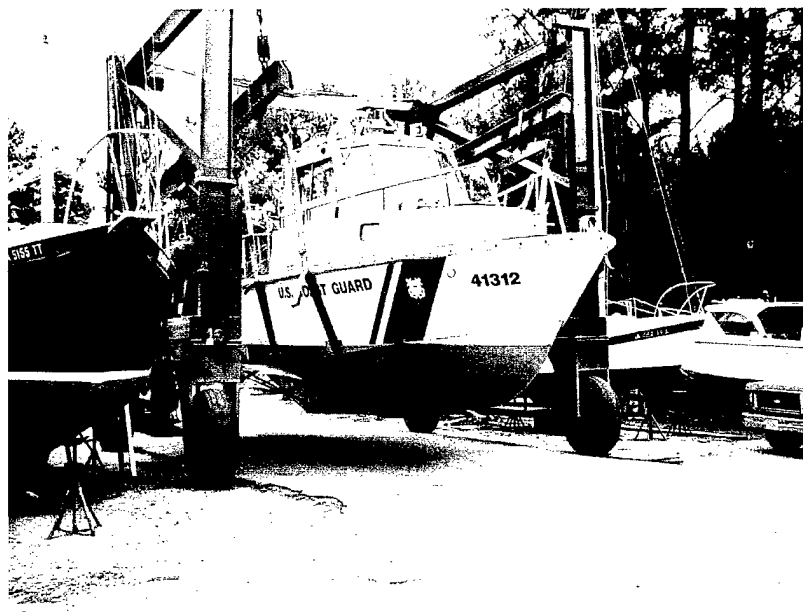
**Figure 5-1.** The duplex coating system as applied to UTB 41312.

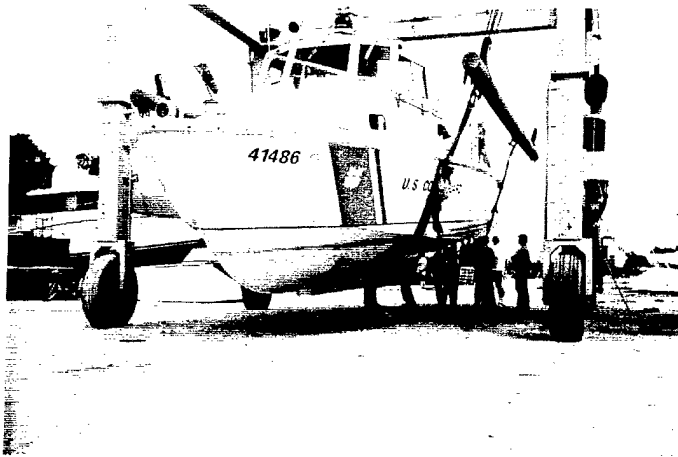
USCG UTB PENNSACOLA, FL  
(18 JULY 96)

A photograph of the duplex system on the UTB 41486 after one year of service is shown in Figure 5-2. The damage was repaired with RTV11® catalyzed with SCM501C®, which contains a high percentage of adhesion promoter to adhere to many types of surfaces. Unfortunately, the repair to UTB 41486 was unsuccessful, mostly likely due to poor surface preparation of the repaired area, and the Duplex system was removed and replaced with a conventional marine paint. The EXSIL2200® coating system on UTB 41345 was also removed at the same time and replaced with a competitor's easy release coating.

**Figure 5-2.** Duplex system applied to UTB 41486 after one year of service.

UTB 41486 proved to be the first instance of delamination on a boat platform that required extensive repair. The duplex coating system had been rolled on prior to the development of spraying expertise. A dive inspection in the summer of 1996 reported that the coating was "peeling off" and the hull was severely fouled. When the boat was pulled from the water for repairs in September 1996, the damage was found to be much less extensive than reported; only 10 ft<sup>2</sup> of the original 400 ft<sup>2</sup> had delaminated, and no hard fouling was observed (except on exposed epoxy paint).

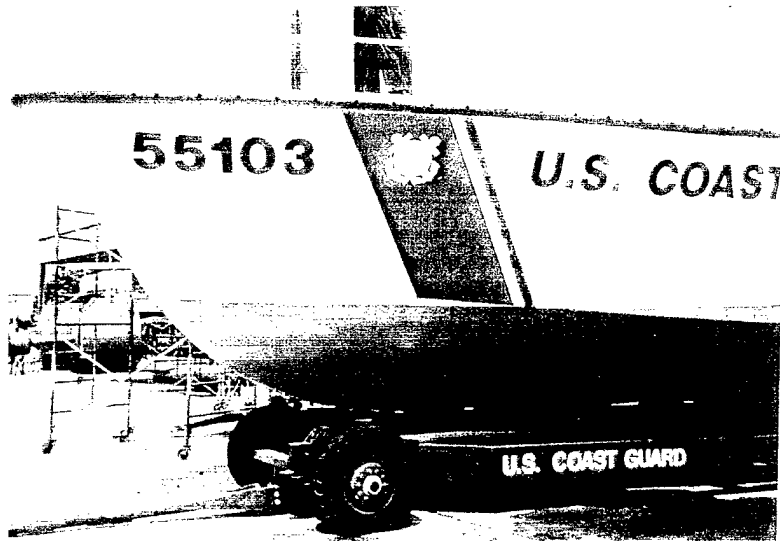
The duplex coating on the USCG 55103 (Parramore) is shown in Figure 5-3. An inspection after four months of service showed very good performance; a gradient of increasing fouling toward the keel indicated self-cleaning ability, and minor sand abrasion damage at the rudders and keel showed the coating's durability and good adhesion. The coating on the Parramore was removed without warning in 1997. Personnel at Yacht Maintenance in Cambridge, MD, where the boat was pulled for recoating, reported that the coating was in excellent condition when the boat was pulled and that the little macrofouling that existed was easily cleaned from the hull.

**Figure 5-3.** Duplex coating as applied to USCG 55103 (Parramore).
